REPAIR PROCEDURE ON VEGA SRM SKIRT

The aim of the present work is to present a repair procedure for composite skirt of VEGA Solid Rocket Motors (SRM), validated on scaled cylinder representative of the Skirt of the P80-SRM.

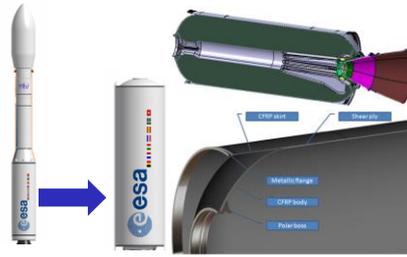
VEGA LV is currently equipped with 3 SRMs and the biggest one is currently the P80, which is shown in picture below.

Figure 1: SRM case architecture.

The SRM composite structural Case can be schematized as a cylindrical pressure vessel with ending domes which mainly sustains the internal pressure, due to propellant combustion, and two cylindrical Skirts, connecting the SRM to the adjacent stages, which have to sustain quite high compressive loading due to Launch Vehicle maneuver, external aerodynamic and SRM thrust.

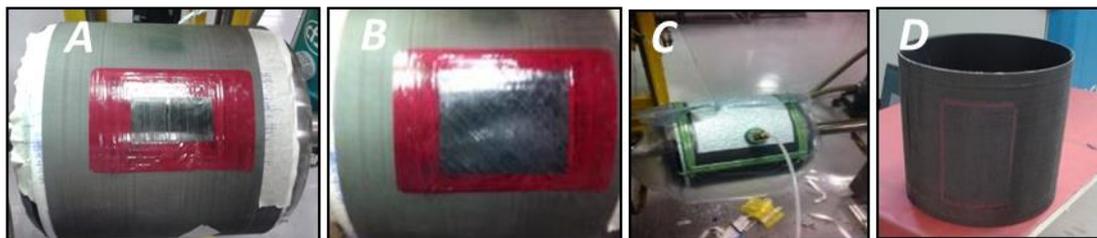
The novel Tape prepreg was used to laminate the repairing patches by hand layup process. On the scarfed surface of the cylinder, an adhesive film (3M scotch weld, TMaf163/2) was applied, with the aim to ensure the adhesion between the repairing patch and the scarf on the cylinder. Then the plies of novel tape prepreg were cut and applied according to designed dimensions and orientations (Figure 9 A, B).

The vacuum bag was applied directly on the surface of the Cylinder (Figure 9 C). The cure cycle was optimized for the resin developed in the project. Figure 9 D shows the final repaired cylinder after the cure and trimming processes.

Figure 9. Hand lay-up of the repairing patch, vacuum bag and repaired scaled cylinder Skirt
